# Manhole Inspection Summary

Manhole # S45MM\_045MH

Insp Date: **3/25/08 12:46 PM**

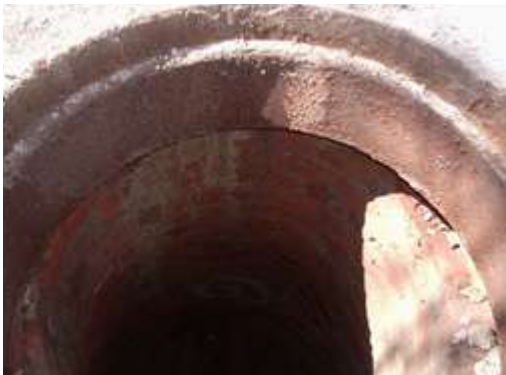
Defect 1

Condition: ☐ Sound ☐ Cracked ☐ Root Intrusion ☒ **Loose Brick** ☐ Deteriorated

Infiltration: ☐ None ☐ Joint ☐ Cracks ☒ **Mortar** ☐ Roots ☒ **Wall**

Adjustment Joint

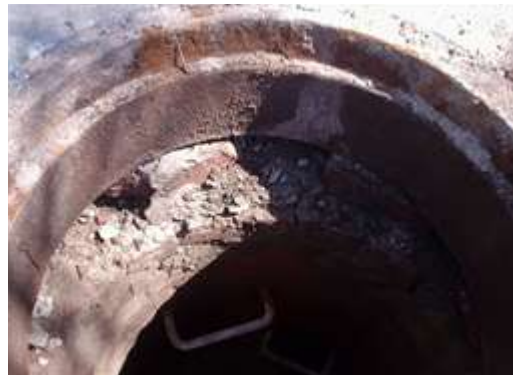
Defect 2

Offset: **4** (in.)

☒ **Leaks**

Offset

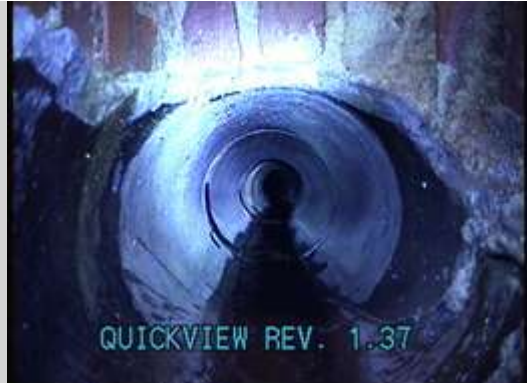
12 O'Clock Outflow

8 in. Circular Gravity Sewer  
Pipe Out @ 12 O'Clock

Pipe Height: **8.4** (in.) Rod and Bar (Angled)  
Pipe Material: **Clay** ☐ Pipe Lined  
Invert Depth: **10.00** (ft.) Flow Characteristics: **Fast**  
Deposits: ☒ None ☐ Mud ☐ Sludge ☐ Debris ☐ Grease  
Silt Depth: (in.) Deposits Extent:  
Infiltration: **None** Pipe Seal Cond: **Sound**

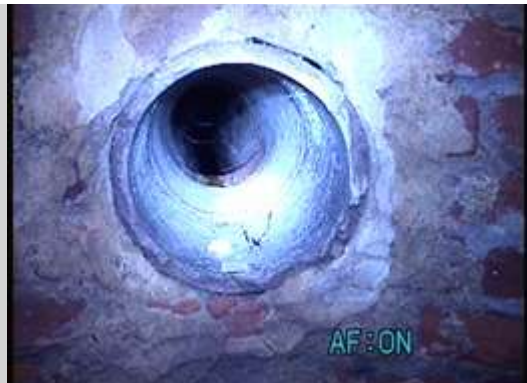
3 O'Clock Inflow

8 in. Circular Gravity Sewer  
Pipe In @ 3 O'Clock

Pipe Height: **8.4** (in.) Rod and Bar (Angled)  
Pipe Material: **Clay** ☐ Pipe Lined  
Invert Depth: **6.20** (ft.) Flow Characteristics: **Slow**  
Deposits: ☒ None ☐ Mud ☐ Sludge ☐ Debris ☐ Grease  
Silt Depth: (in.) Deposits Extent:  
Infiltration: **None** Pipe Seal Cond: **Broken**

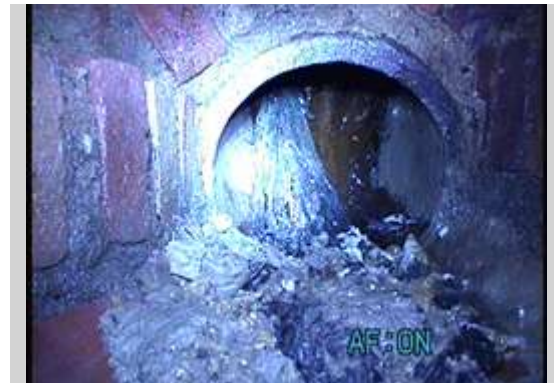
Drop In @ 3 O'Clock

Drop: **Inside** Rod and Bar  
Angled: **Yes** Reading: **8.70** (ft.)  
Inv Depth: **9.70** (ft.)  
Drop Condition: **Partly Clogged**

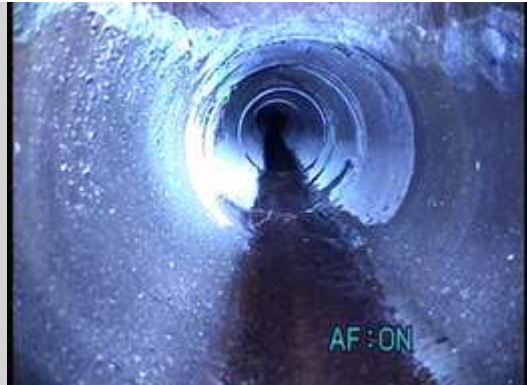
6 O'Clock Inflow

Pipe In @ 6 O'Clock

Invert Depth: **9.90** (ft.) Flow Characteristics: **Fast**

Infiltration: **None** Pipe Seal Cond: **Sound**
